Abandoned Uranium Mine Site Assessment for the Charlotte Site (NM0143)

FINAL REPORT

NM0143

May 28, 2010

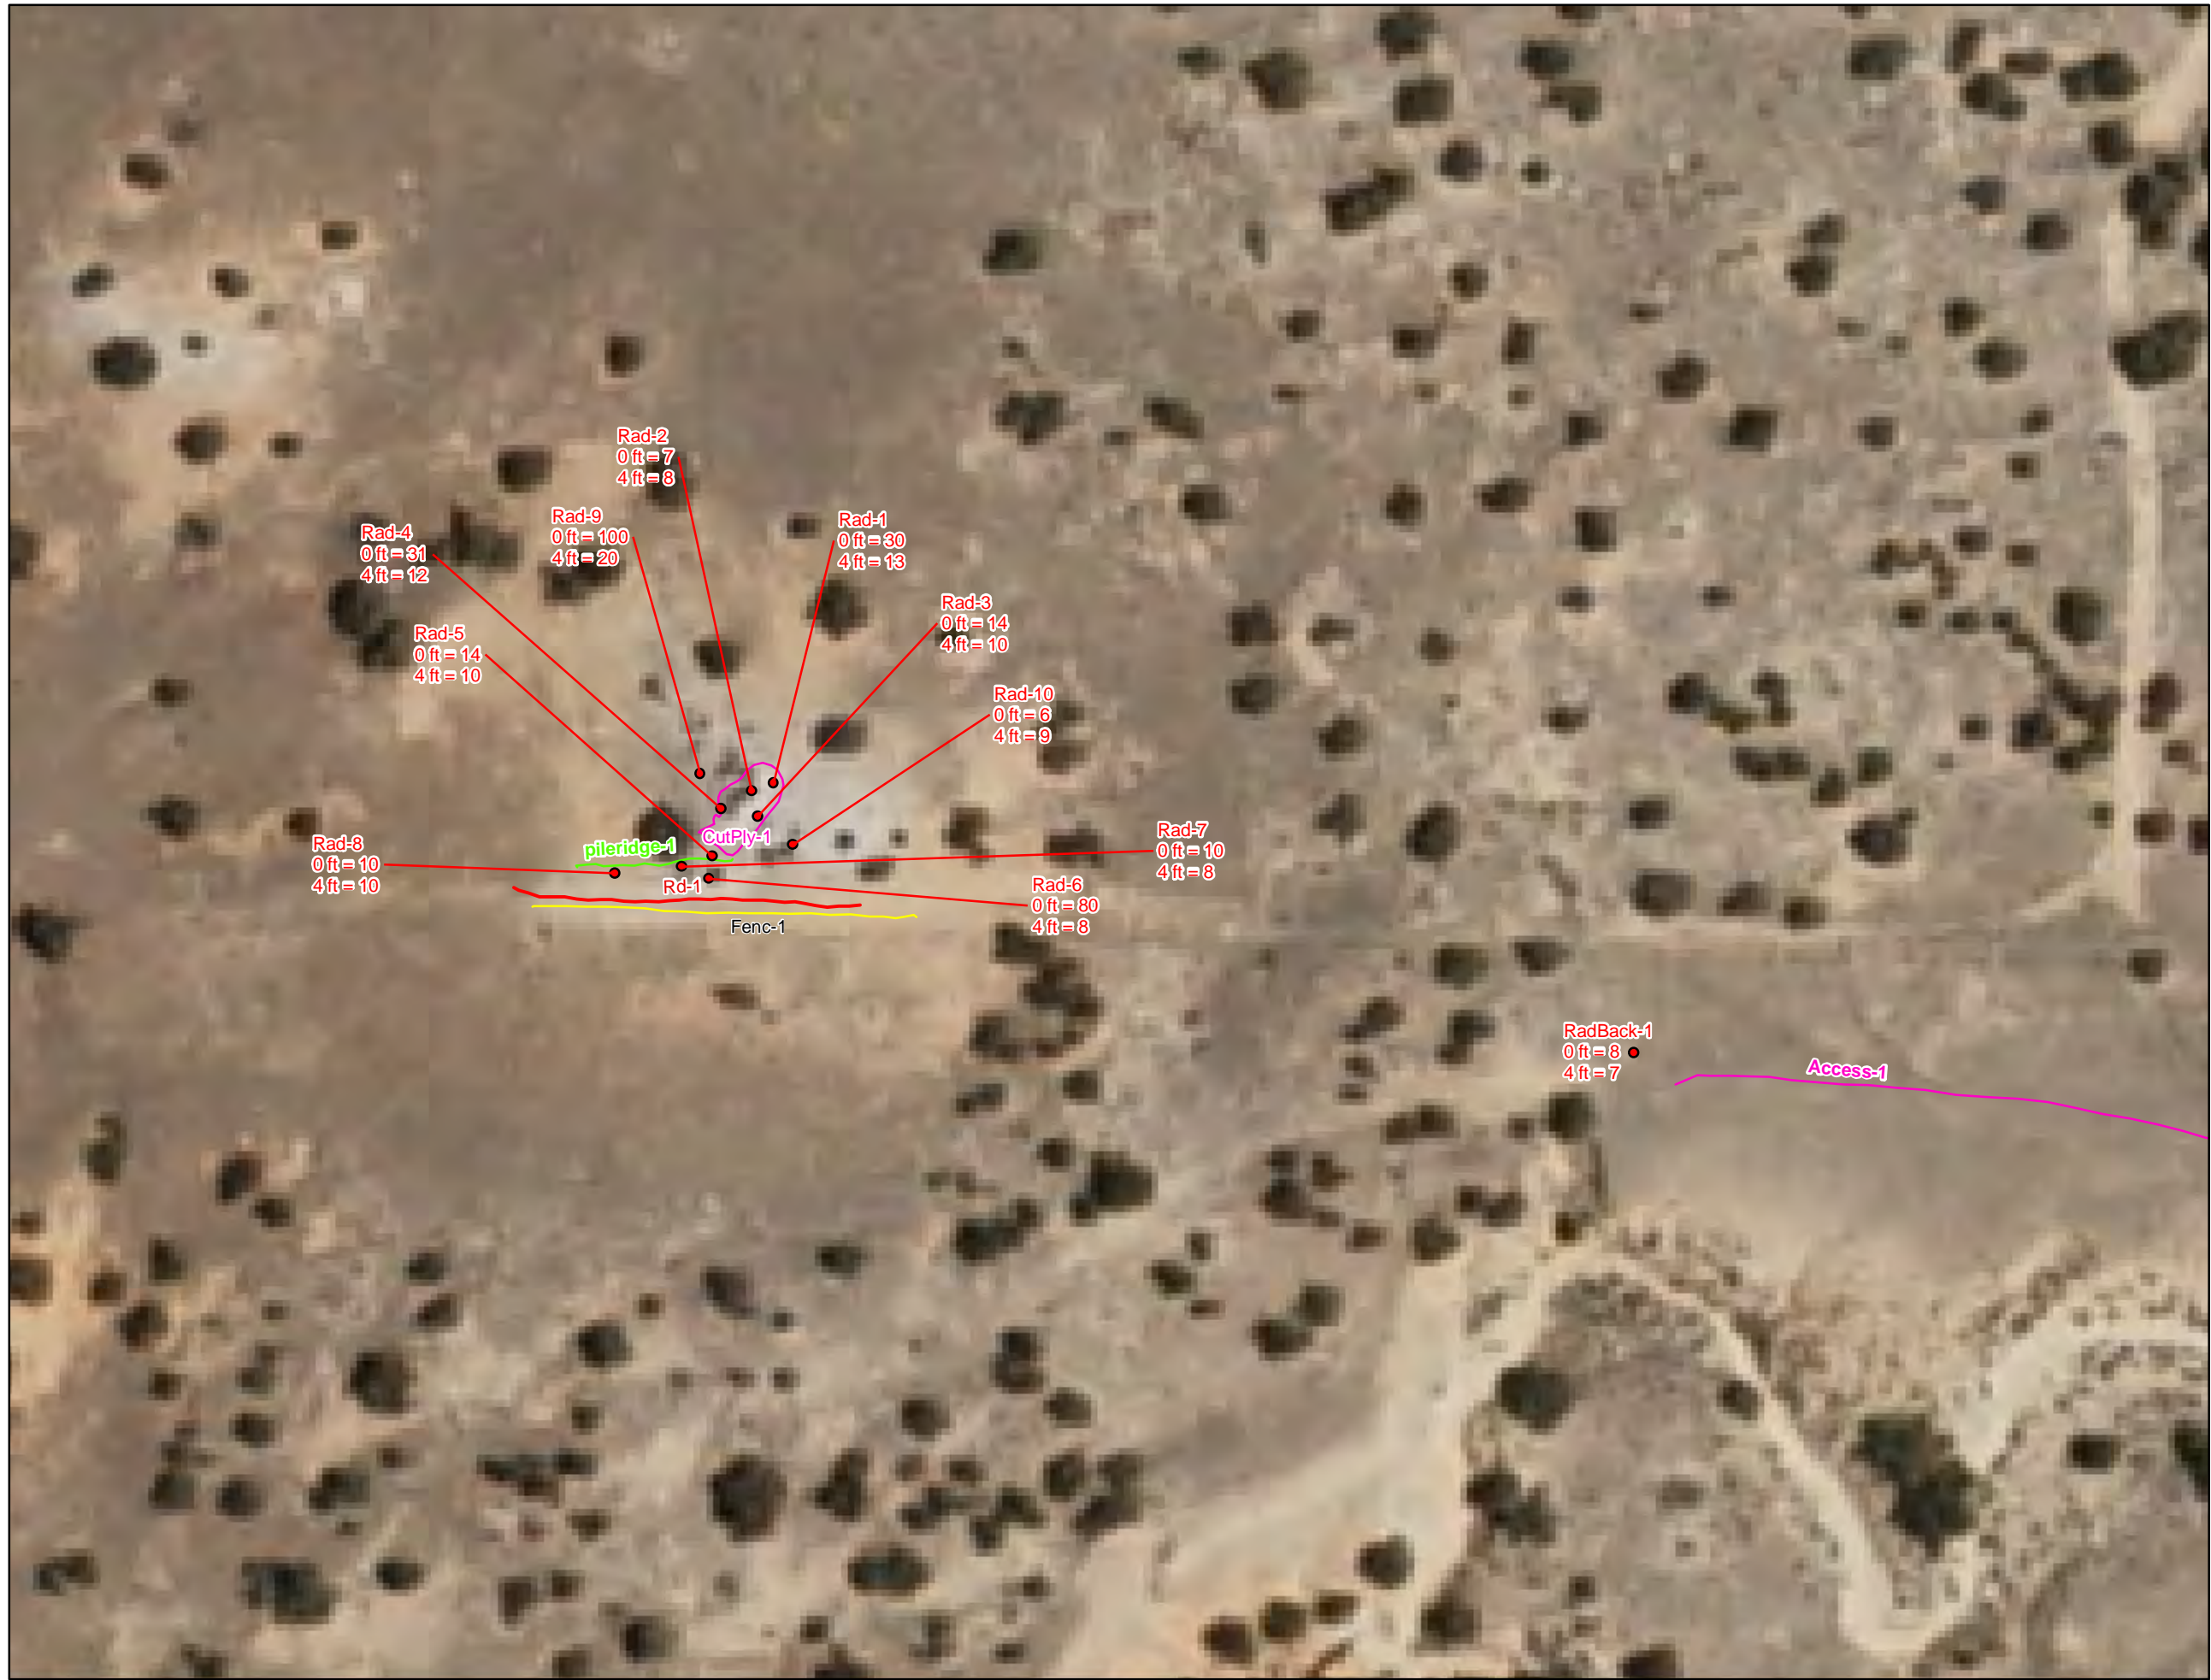
Figure 4a
Site Map on
Aerial Photo
NM0143-Charlotte
 Abandoned Uranium
 Mine Assessment

and Figures 4a and 4b for the locations of the AUM Site features. Note that the scale differs between Figure 4a (aerial photo) and 4b (ownership map).

radiation readings taken at the AUM Site and Figures 4a and 4b for the locations of the radiation readings.

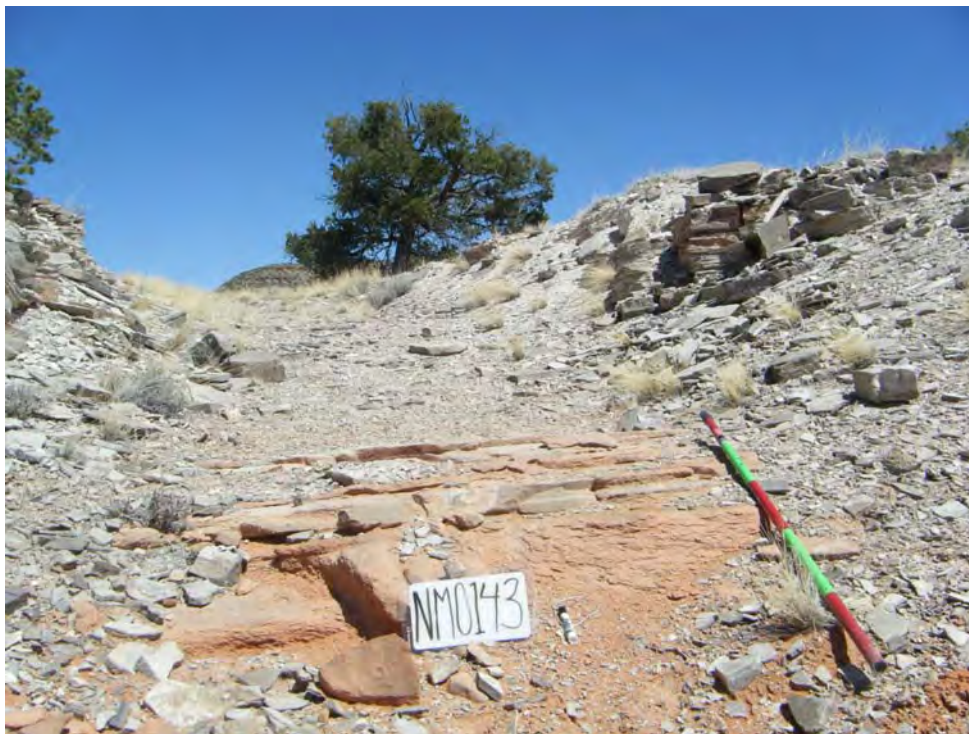
One open cut was found at the AUM Site (CutPly-1). This open cut is located at the top of an isolated hill capped by rocks of the Todilto Formation. The cut exposes both the Todilto Formation and the underlying Entrada Formation. The maximum gamma ray reading in this cut was 31 $\mu\text{R/hr}$ at 0 ft. This open cut appears in photo (a) in Anderson (1980).

Photo 1-Looking north at CutPly-1. This view is similar to photo (a) in Anderson (1980).

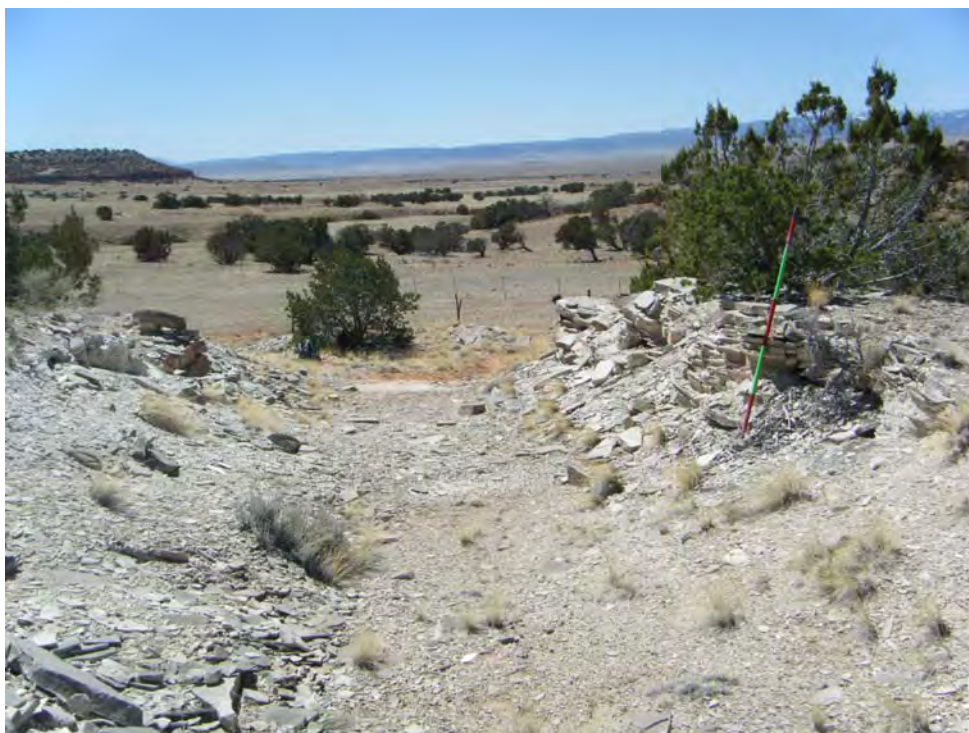
Photo 2-Looking south at CutPly-1.

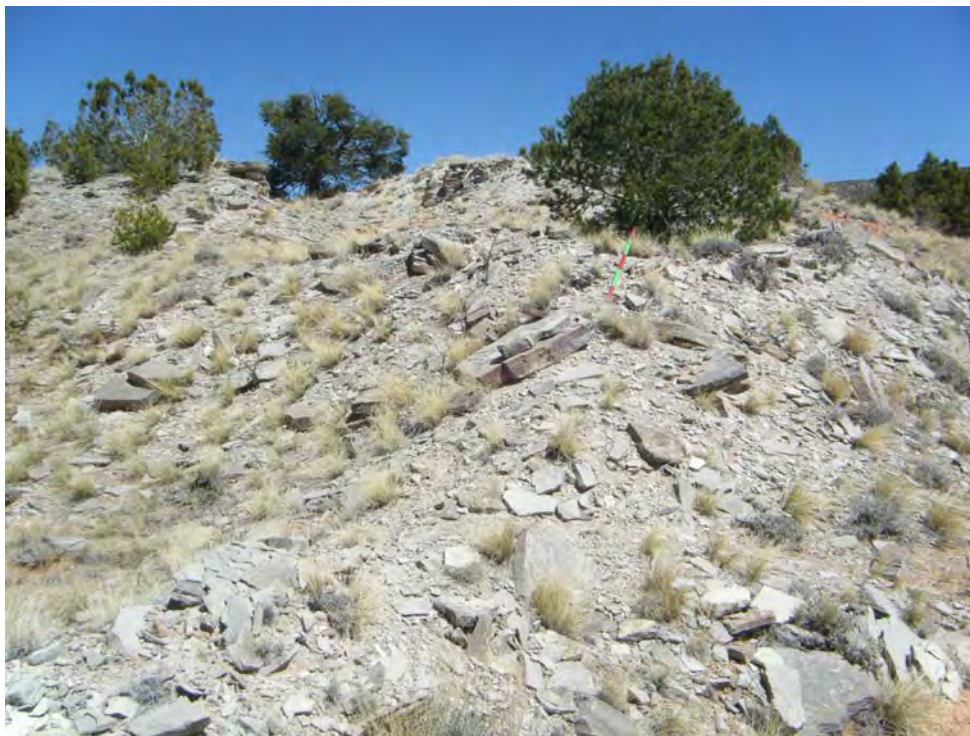
One pile (PileRidge-1) is located on the AUM Site. This pile parallels the mine road (Rd-1) to the south of CutPly-1. The maximum gamma ray reading on this pile was 80 $\mu\text{R/hr}$ at 0 ft above ground level.

Photo 3-Looking northeast at PileRidge-1.

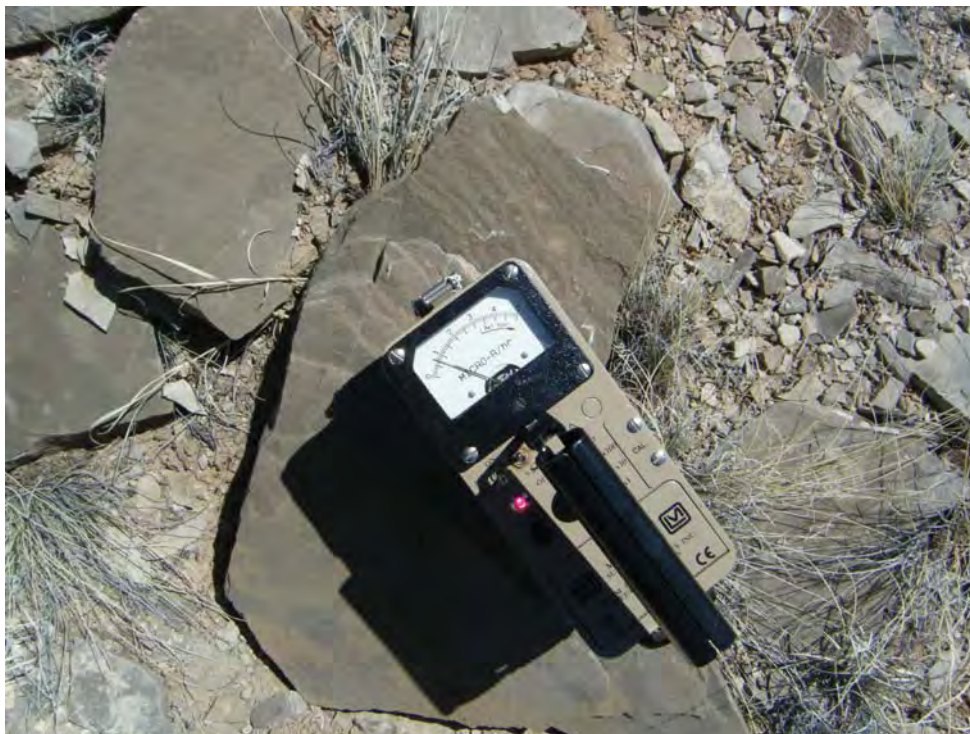
The maximum gamma radiation reading for the AUM Site was 100 $\mu\text{R/hr}$ at 0 ft above ground at radiation survey point Rad-9 (see Photo 5 in Appendix A). This reading was taken on a tabular slab of Todilto Formation limestone.

Photo 5-Radiation survey point Rad-9, taken on Todilto Limestone, measuring 100 μ R/hr at contact.

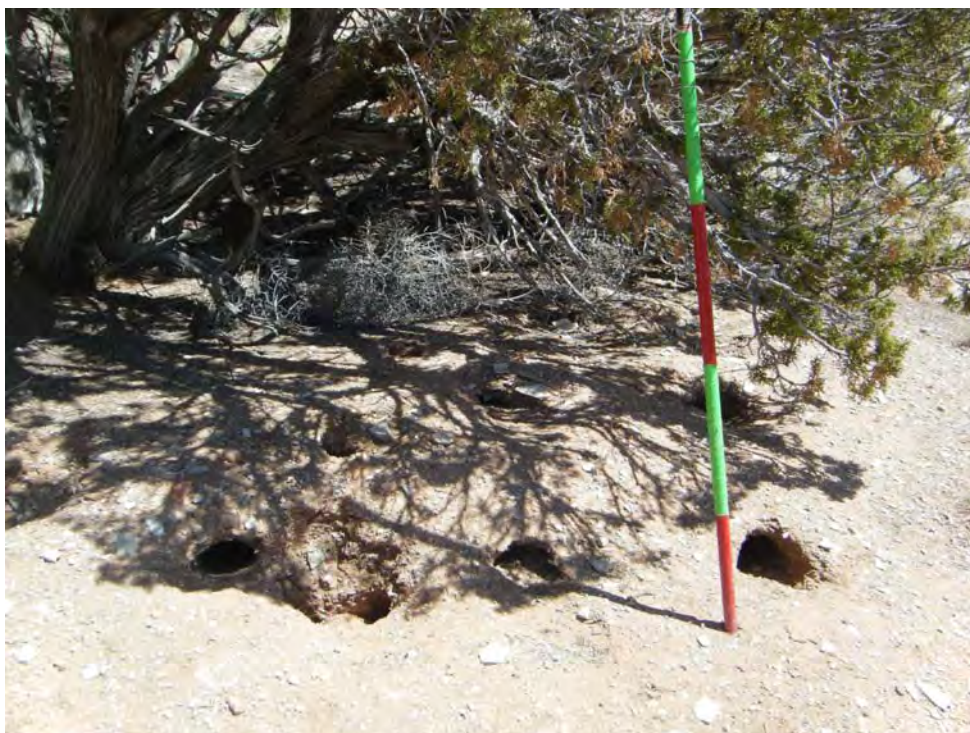
Wildlife burrows were noted onsite (see Photo 6 in Appendix A). The type of animal that produced these burrows is unknown. Deer scat was found onsite, and scrub jays were observed nearby.

Photo 6-Wildlife burrows west of CutPly-1.
